Molded Part Defect Identification

The Challenge

Polymer Solutions received a molded silicone part that contained a small discoloration on the tip. Our client needed to understand the composition of the defect, in order to determine how it got there.

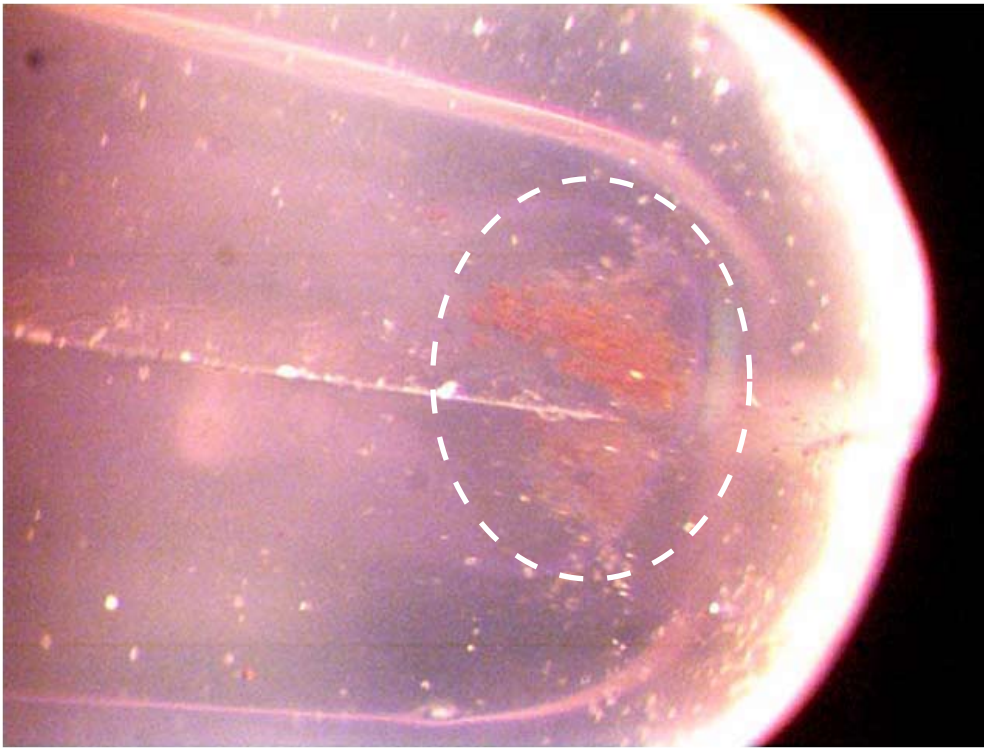
Figure 1: Optical micrograph (32x) of the defect region of the silicone part.

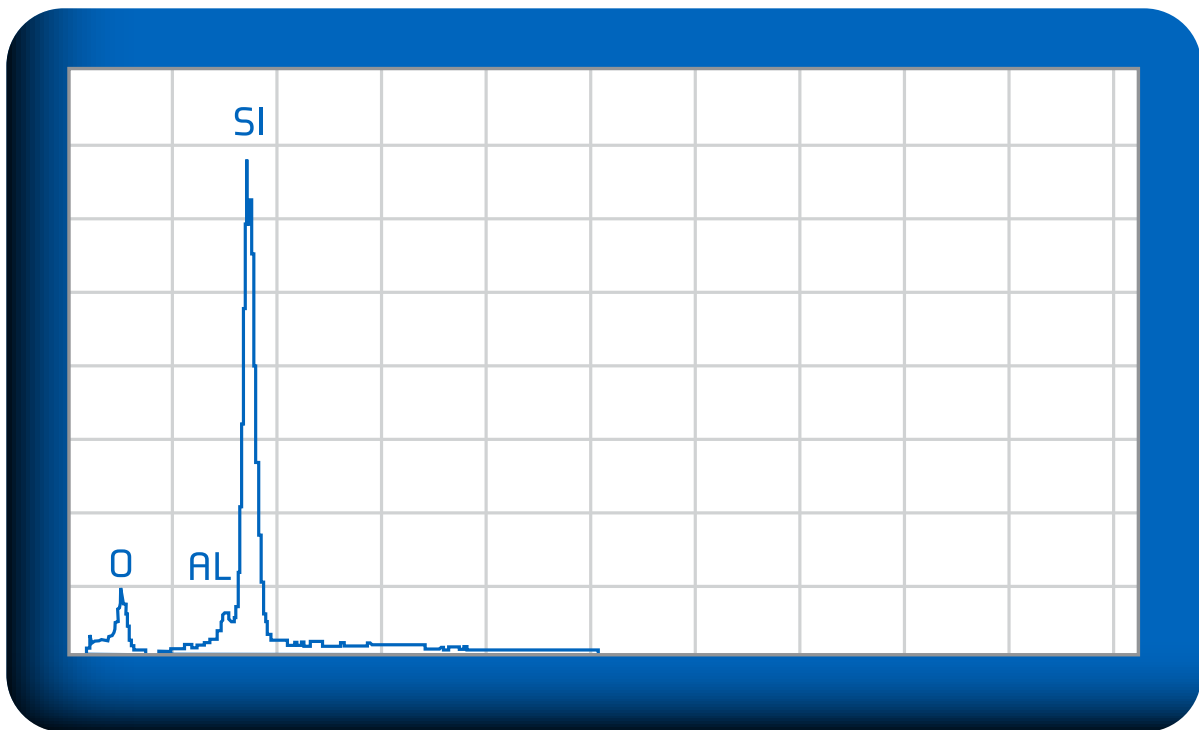
Figure 2: EDS spectrum of a reference region of the silicone part.

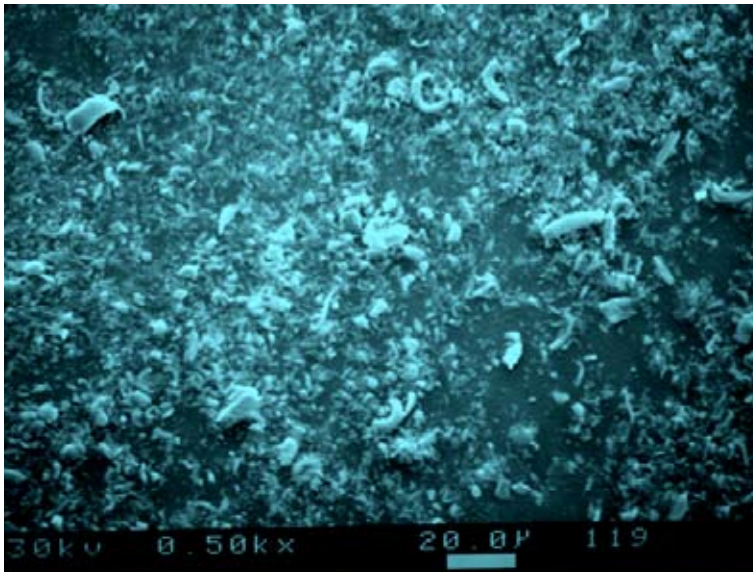
Figure 3: SEM micrograph (500x) of the defect region.

The defect region was then viewed using SEM (Figure 3). Many small particles were embedded in the surface of the silicone. Wide scan EDS analysis of the defect region revealed the presence of silicon, oxygen, aluminum, cobalt, chromium, and molybdenum (Figure 4).

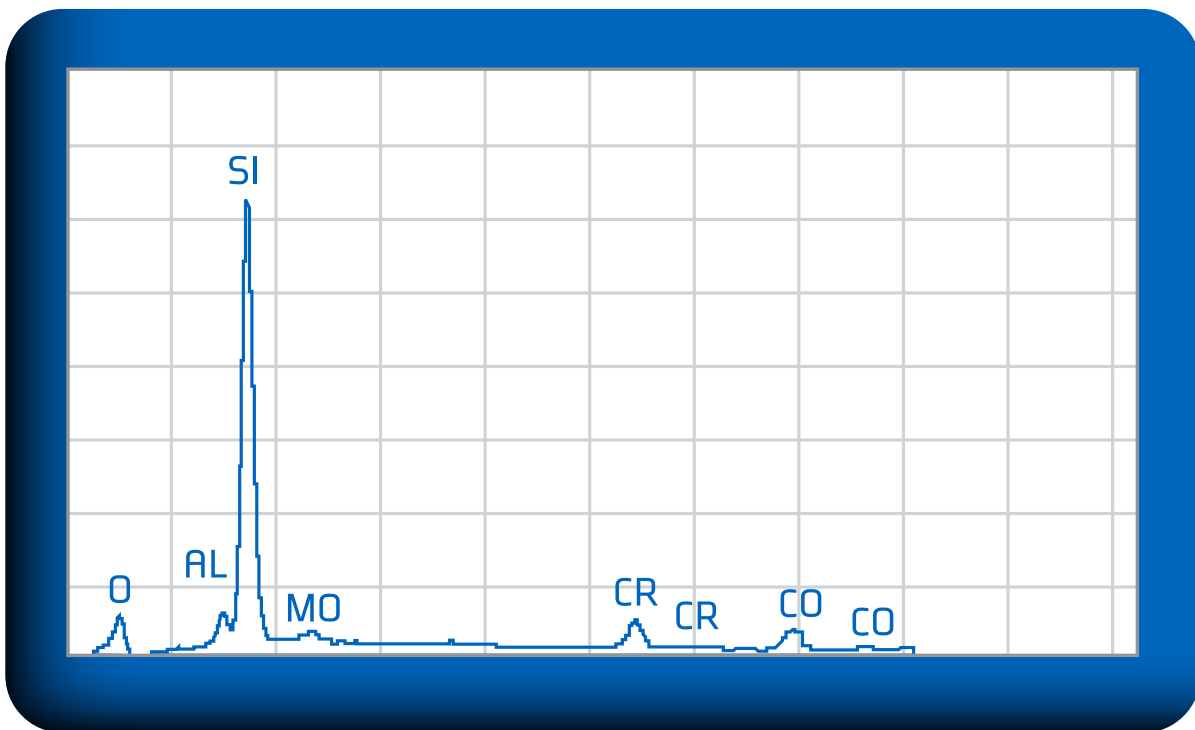
Figure 4: EDS spectrum of the defect region (wide scan).

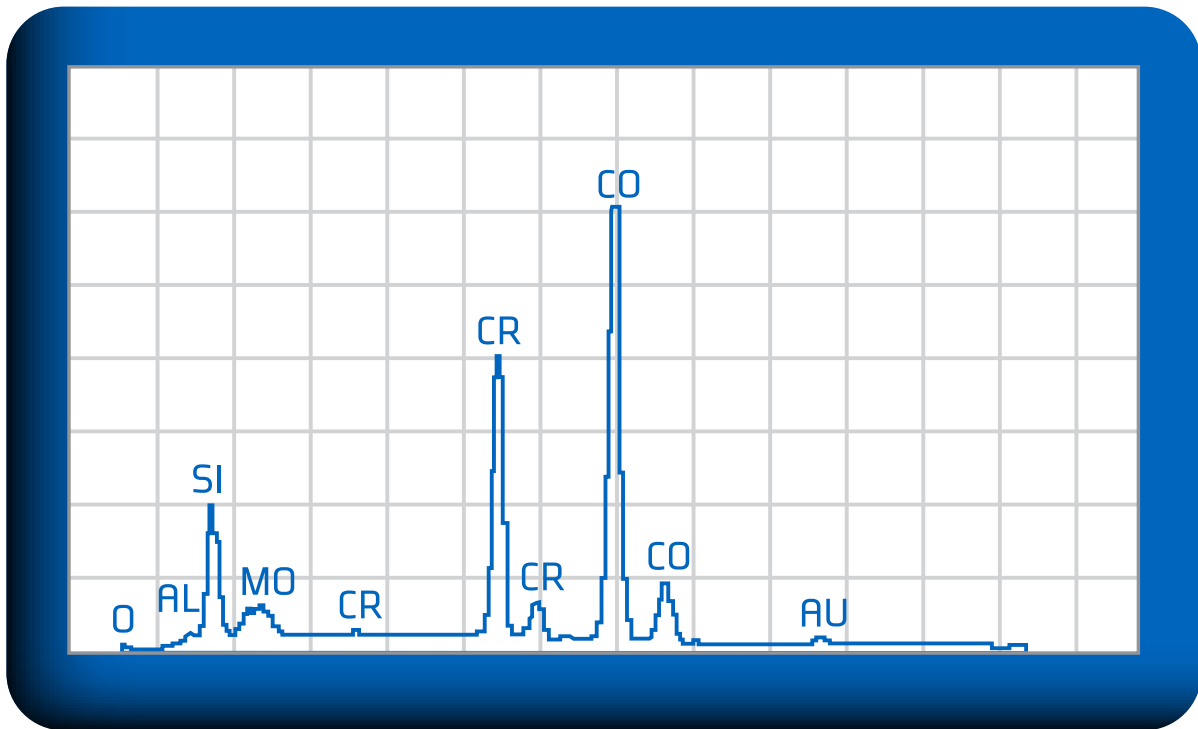
Next, one of the particles in the defect region was isolated for spot mode analysis. Spot mode EDS analysis provides a spectrum of a specific spot on a defect particle. High concentrations of cobalt, chromium, and molybdenum were detected (Figure 5), compared to the wide scan (Figure 4).

Figure 5: EDS analysis of a defect particle (spot mode).

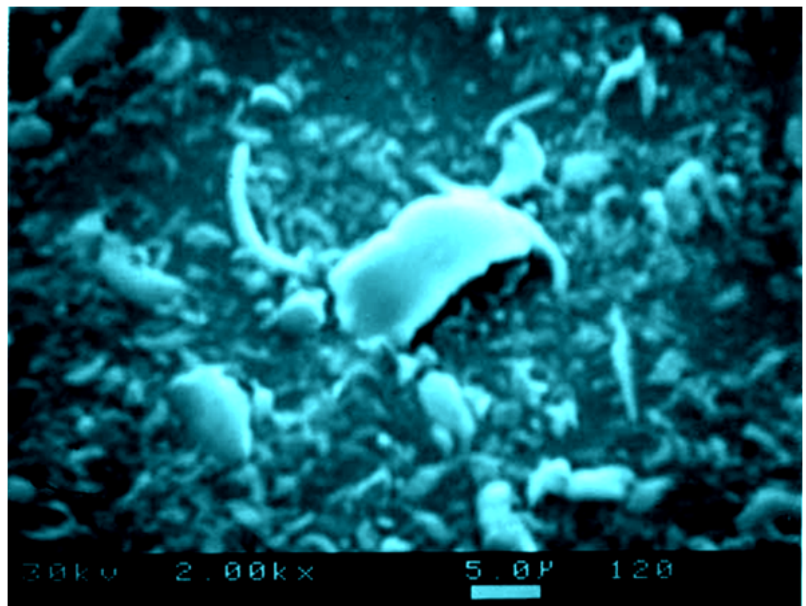
The maps show that the particle in Figure 6 is composed of cobalt, chromium, and molybdenum, and is embedded in a silicone matrix. The distribution of these three metals in the particle was consistent with an alloy of cobalt, chromium, and molybdenum. Table 1 lists the atomic concentrations of each chemical element that was detected in the reference region and in the specific defect particle.

Figure 6: SEM micrograph (2,000x) of the defect particle.

Our testing showed that the defect was an alloy of cobalt, chromium, and molybdenum, embedded in the silicone matrix. This alloy was present in another process within the same manufacturing facility, and was found to be the contaminant in the silicone part.

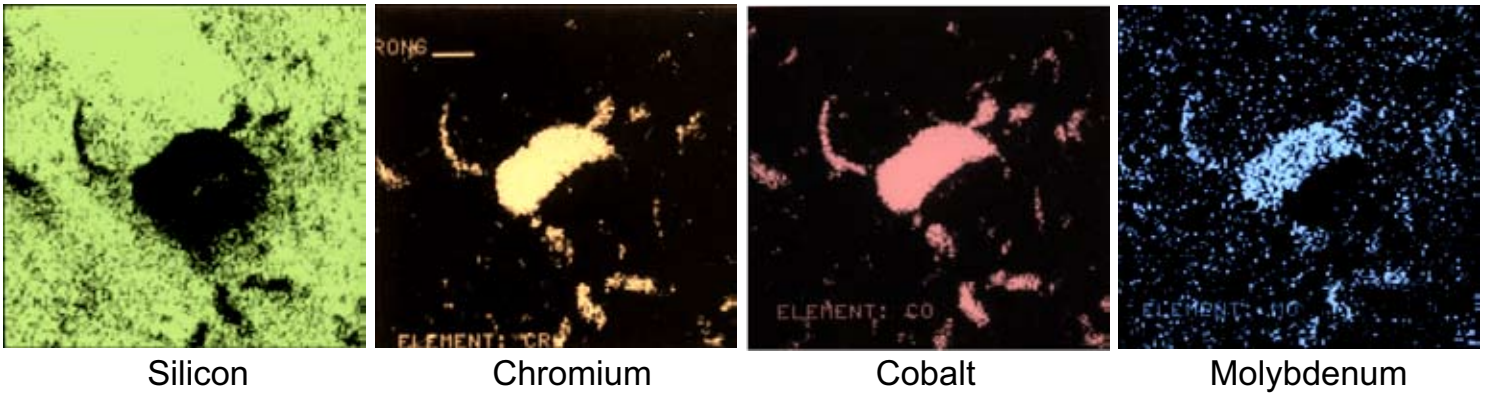
In order to illustrate the spatial distribution of the elements in the defect region, elemental maps of the defect were acquired (Figure 6). The elemental maps (Figure 7) illustrate the spatial position of the chemical elements that were detected, and relate directly to the SEM micrograph that was obtained prior to mapping (Figure 6).

Figure 7: Elements detected in regions corresponding to Figure 6.
