Molded Part Defect Identification

The Challenge

Polymer Solutions received a molded silicone part that contained a small discoloration on the tip. Our client needed to understand the composition of the defect, in order to determine how it got there.

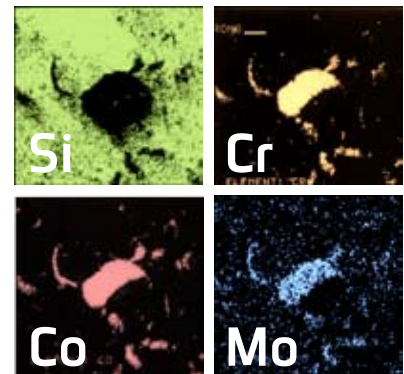
SEM-EDS 2,000x

In order to illustrate the spatial distribution of the elements in the defect region, elemental maps of the defect were acquired (Figure 6). The elemental maps (Figure 7) illustrate the spatial position of the chemical elements that were detected, and relate directly to the SEM micrograph that was obtained prior to mapping (Figure 6).

The maps show that the particle in Figure 6 is composed of cobalt, chromium, and molybdenum, and is embedded in a silicone matrix. The distribution of these three metals in the particle was consistent with an alloy of cobalt, chromium, and molybdenum. Table 1 lists the atomic concentrations of each chemical element that was detected in the reference region and in the specific defect particle.

Our testing showed that the defect was an alloy of cobalt, chromium, and molybdenum, embedded in the silicone matrix. This alloy was present in another process within the same manufacturing facility, and was found to be the contaminant in the silicone part.
